APPENDIX G DFO AND TFO RESPONSES

EDTI-AESO-2019APR09-001

Reference: EDTI TFO

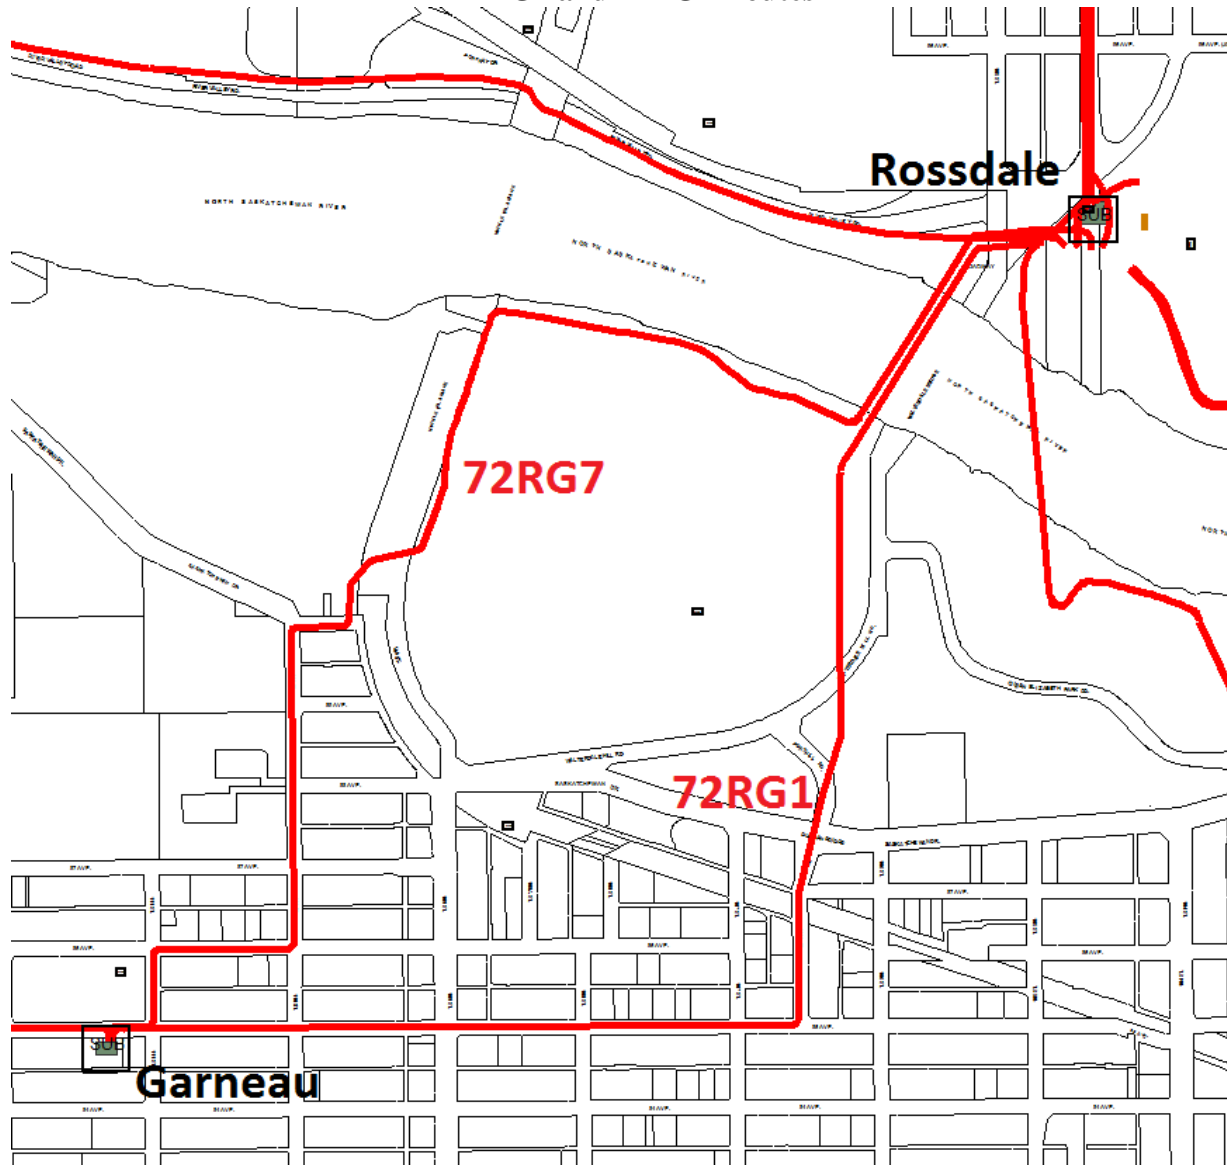
Figure EDTI-AESO-2019APR09-002-1
72RG1 and 72RG7 Routes

The two circuits connect to gas insulated switchgear (“GIS”) within the Garneau substation. From the switchgear lineup, each phase exits the north side of Garneau substation building through a 3” riser pipe. There is approximately 1 metre separating these pipes. The riser pipes come together (3 phases per circuit) in trifurcators (1 trifurcator per circuit) outside the building, and each circuit is then enclosed in its own 5” pipe. As shown in Figure EDTI-AESO-
